## FINAL REPORT

### SERIOUS INCIDENT OF CESSNA-152 AIRCRAFT, REG S2-ADQ OCCURRED ON 08 OCTOBER 2020 AT RAJSHAHI AIRPORT (VGRJ), BANGLADESH

### Investigation into ‘Serious Incident’ following ‘Runway Excursion’ of Cessna-152 Aircraft, Reg. No. S2-ADQ of Bangladesh Flying Academy and General Aviation Ltd, Occurred on 08 October 2020, at VGRJ, Shah Makhdum Airport, Rajshahi, Bangladesh

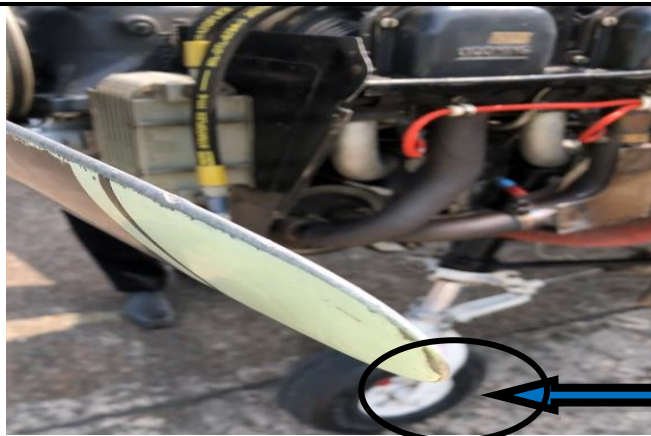
<p>(d) While in the grassy area, the aircraft sustained a propeller strike (splash of mud was found on the propeller) and left-wing tip leading edge area (splash of mud was found on the wing tip leading edge). Although no visible damage to either the propeller tip or on the surface of wing tip could be detected. The photo is enclosed herewith.</p>

Hit mark of the propeller tip

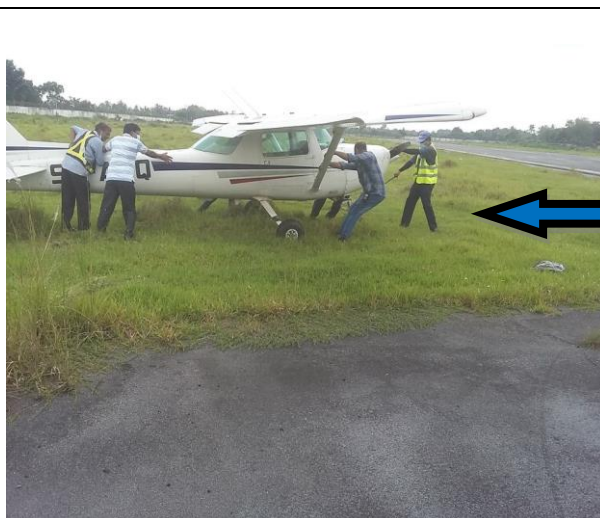
<p>(e) At the point of stoppage, the nose wheel of the aircraft got stuck in the mud leaving about 6-9 inches deep hole in the soft grassy surface (rain). The propeller tip of the aircraft hit the ground by making an approximately 3-inch-deep &amp; 27-inch-wide cut. The left-wing also hit the ground and received mud-splash onto left-wing tip leading edge area by making a mark of 5-inch deep &amp; 14-inch-wide. However, the hit of propeller tip and left-wing tip did not show any visible damage to the propeller-tip or wing surface/tip.</p> <p>(f) According to the SP, the aircraft engine was quickly switched off and when stopped, 'Emergency' was announced to Air Traffic Control tower at 0638 UTC. The SP thereafter, evacuated the aircraft normally by opening the aircraft door.</p> <p>(g) Reconstruction of the significant portion of the flight path was not applicable for this incident.</p>

Aircraft into the grassy area and stopped at a distance of 25 feet from the dumbbell edge

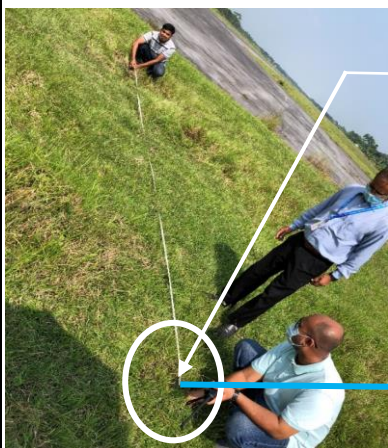
**Suspected hit of elevator tip on grassy field:**

Actual suspected hit of Elevator tip

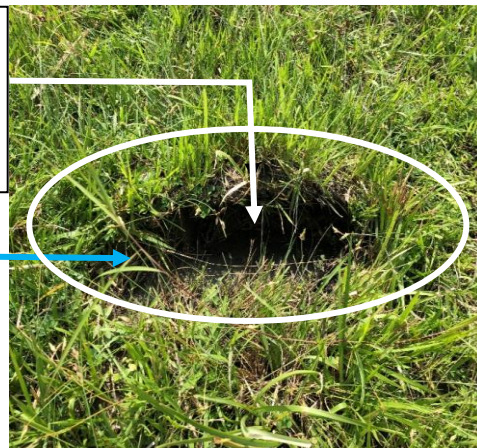
Blow up photo Suspected hit of Elevator tip

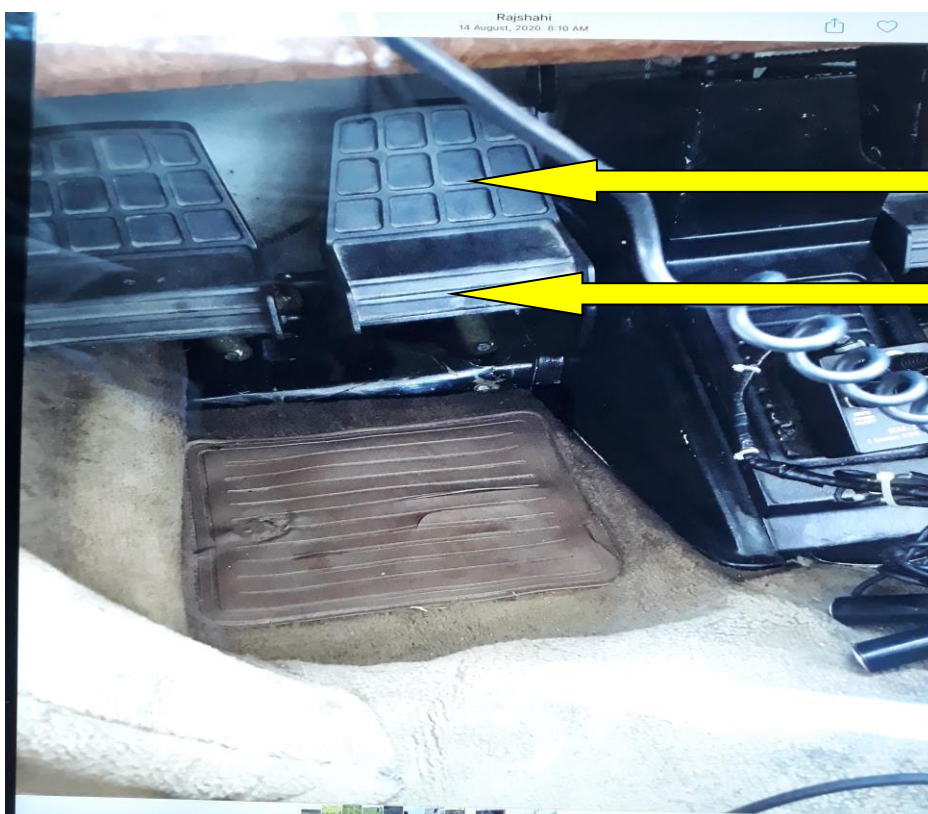
**The brake and rudder of Cessna 152 aircraft:**

**3.2.2 Brake and Rudder system** (f) The brake and rudder system of Cessna 152 aircraft is on the pedals. The upper part of the pedal is brake and the lower part is rudder. The photo of brake and rudder pedal is enclosed herewith. If proper taxi briefing/practice/training is not given, ab-initio student pilots are likely to confuse with the application of brake and rudder especially during an emergency.
