## FINAL REPORT

### SERIOUS INCIDENT OF CESSNA-152 AIRCRAFT, REG S2-ADQ OCCURRED ON 08 OCTOBER 2020 AT RAJSHAHI AIRPORT (VGRJ), BANGLADESH

### Investigation into ‘Serious Incident’ following ‘Runway Excursion’ of Cessna-152 Aircraft, Reg. No. S2-ADQ of Bangladesh Flying Academy and General Aviation Ltd, Occurred on 08 October 2020, at VGRJ, Shah Makhdum Airport, Rajshahi, Bangladesh

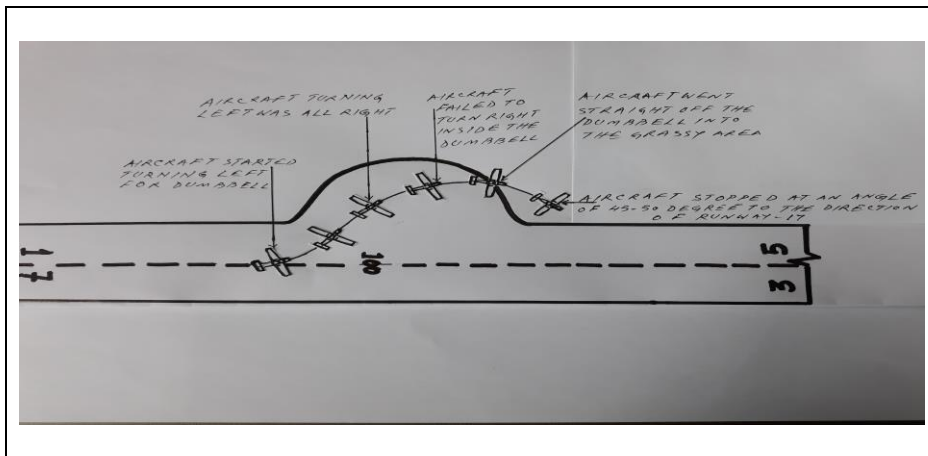
3.1.1.5 Point of intended landing	VGRJ, Rajshahi
3.1.1.6 'Flight preparation'	Flight preparation was good
3.1.1.7 Description of the flight and events leading to the accident, including reconstruction of the significant portion of the flight path, if appropriate.	<p>(a) The Student Pilot (SP) was scheduled for 'Solo-Flight' after having cleared for the flight by the Company Instructor Pilot (IP). Before the solo flight, the SP completed the required flying training and was cleared for this 'First Solo' Flight.</p> <p>(b) The SP took off from VGRJ, Shah Makhdum Airport, Rajshahi, Bangladesh, using Runway 17 at 0630 UTC. The SP completed one circuit and approached on finals for full stop landing. The SP landed the aircraft at 0636 UTC. After touch down and following landing roll, the SP entered the first dumbbell for turning around the aircraft inside the dumbbell to taxi back track to the parking (bay) area.</p> <p>(c) Before entering into the dumbbell, the SP requested the tower for back-track. Rajshahi tower cleared the aircraft to back track and proceed to parking (bay) area. According to the SP, the aircraft was slowed down before entering the dumbbell.</p> <p>(d) The left entry-turn by the SP from the runway to the dumbbell was assumed to be normal. While making right turn inside the dumbbell to turn around, the SP added power and applied right rudder pedal to continue to turn right but the aircraft did not attain the required radius of turn for completing the right U-turn inside the dumbbell. Instead, the aircraft over speeded, went straight off the dumbbell into the grassy area. Sketch of the Serious Incident of Cessna-152 is shown herewith:</p>
